IMPROVEMENTS COMMITTEE

Special Meeting September 18, 2024 at 8:00 a.m.

MEMORANDUM

Subject: Monthly Improvements Committee Updates

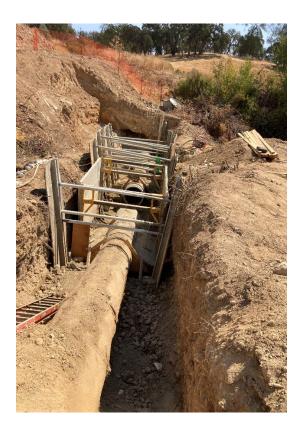
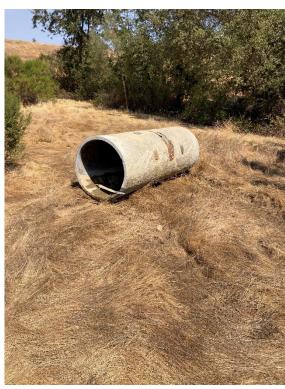
On 8/26/2024, TNT started the repair work on the raw water line. As of 9/5/2024, TNT has removed the section of pipe that is broken and are currently working on fabricating the section of pipe that will be inserted for the repair. Below are pictures of the section of pipe that has been removed. The repair is estimated to be completed and tested by 9/16/2024.

C. Repair Broken Raw Water Conveyance Pipe from Granlees to Calero Reservoir

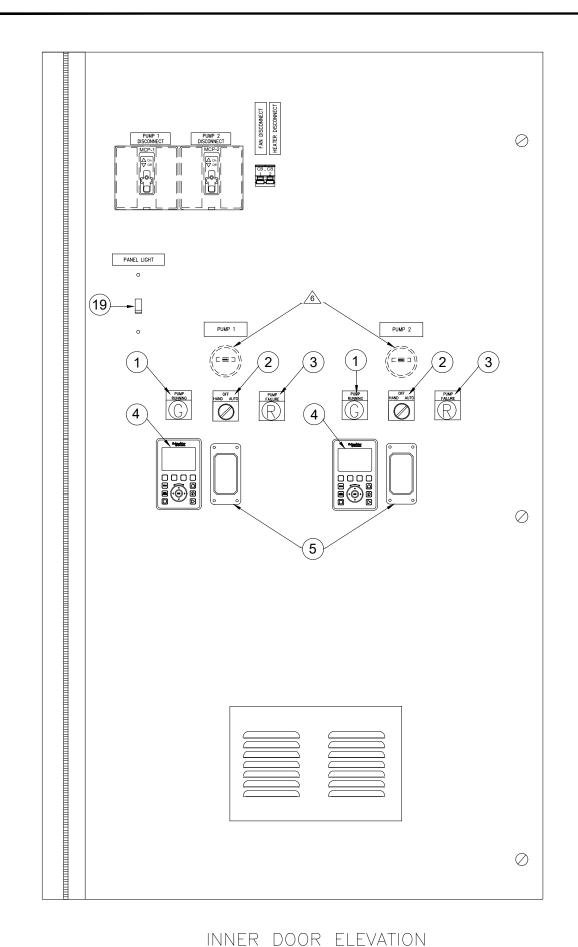
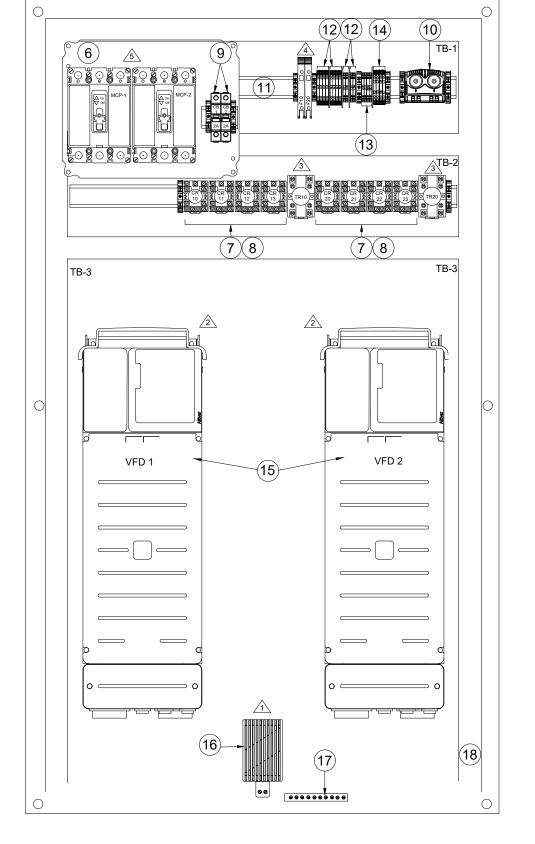
BACKPANEL ELEVATION

4.75" MINIMUM GAP ABOVE & 2" TO THE SIDE OF DEVICE

Drawing E5.0 and BOM changed. The relays replaced with the IDEC RR3B-ULAC120V. About the time relays, we will use the existing materials. See drawing E5.0, note 3 about time relays.
